Assessment of Dam Safety of Coal Combustion Surface Impoundments

Indianapolis Power & Light Company

Petersburg Generating Station

Draft Report

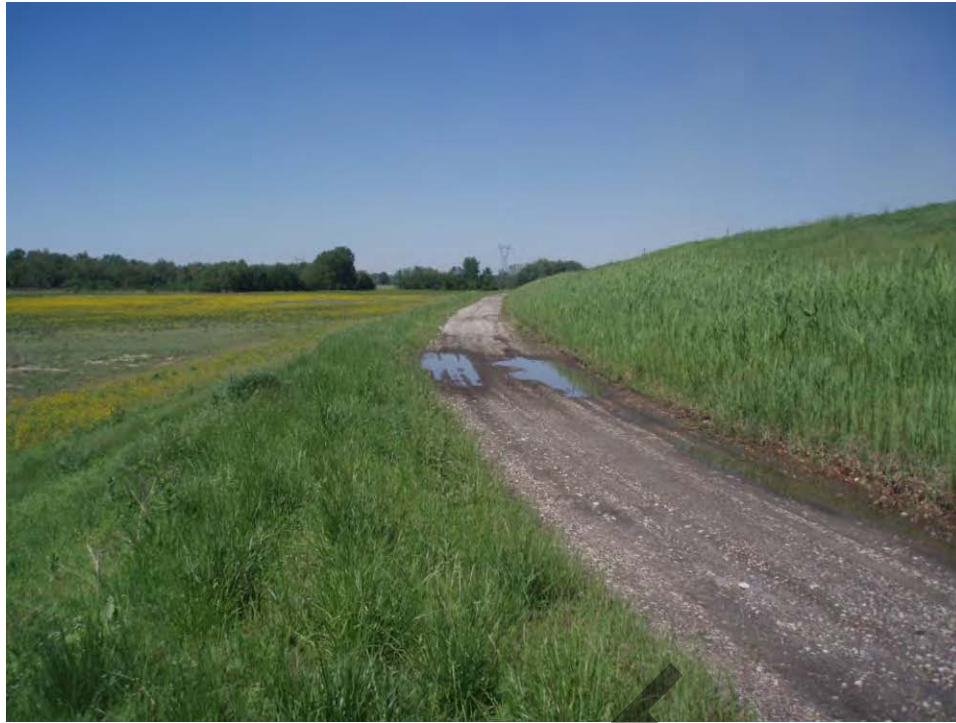
75. Pond B – West embankment bench, looking north. Note inside of bench is wet from recent storm events.

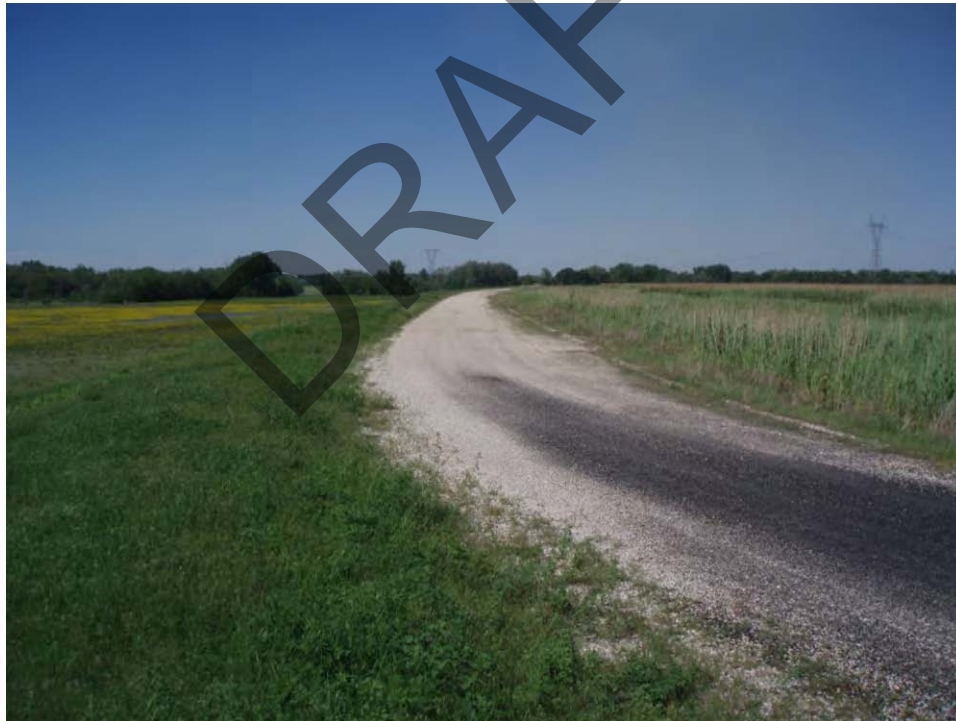
76. Pond B – West embankment crest, looking north.

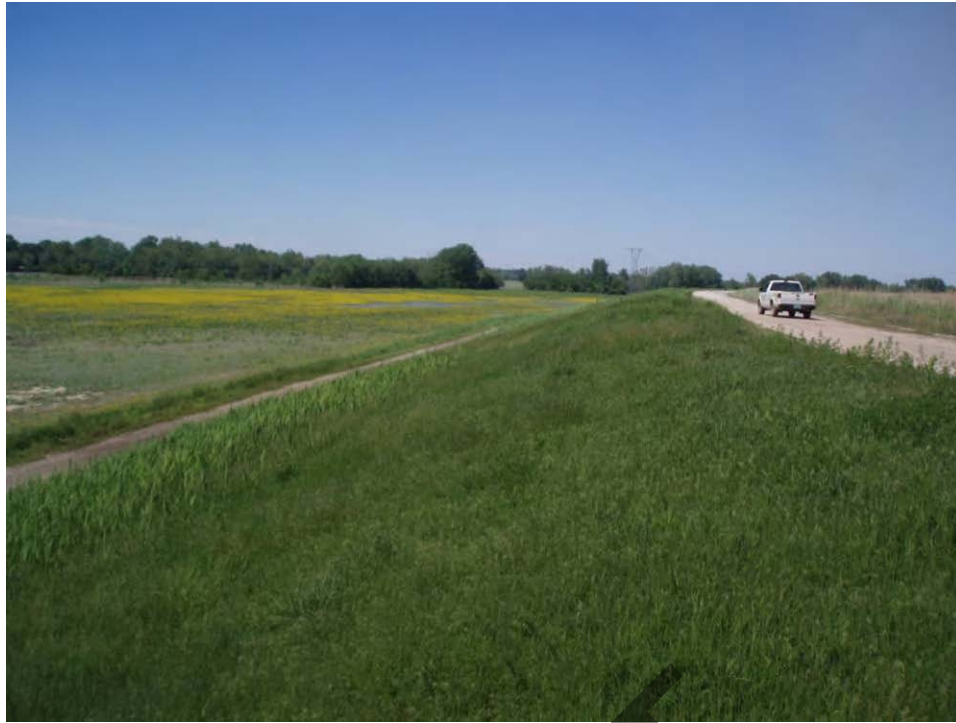
77. Pond B – West embankment upper exterior slope, looking north.

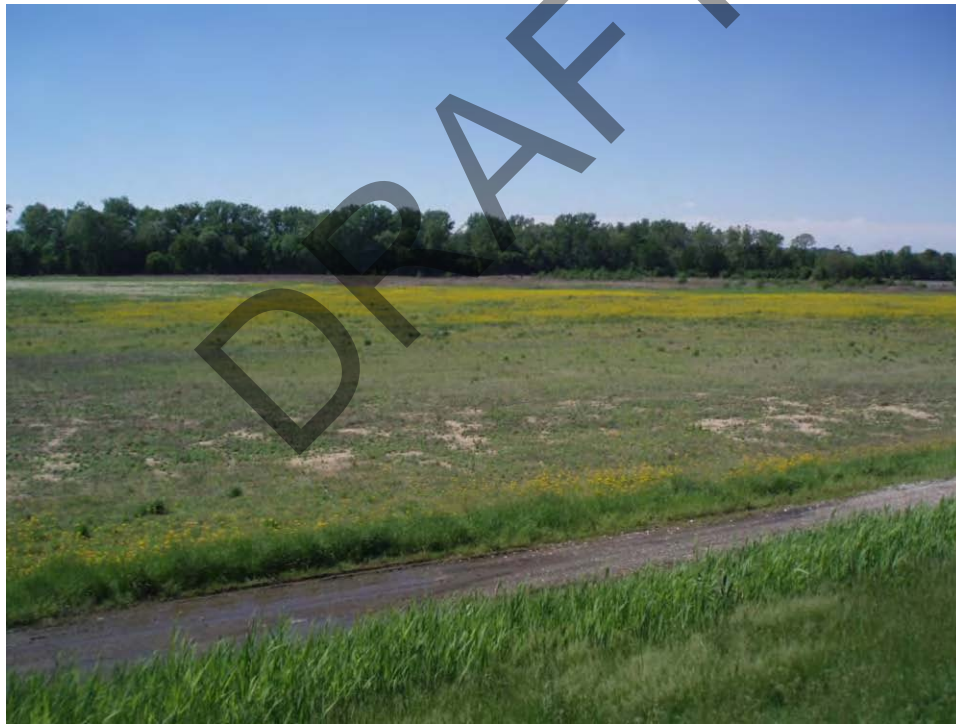
78. Overview of Pond B – West embankment, downstream area, looking west.

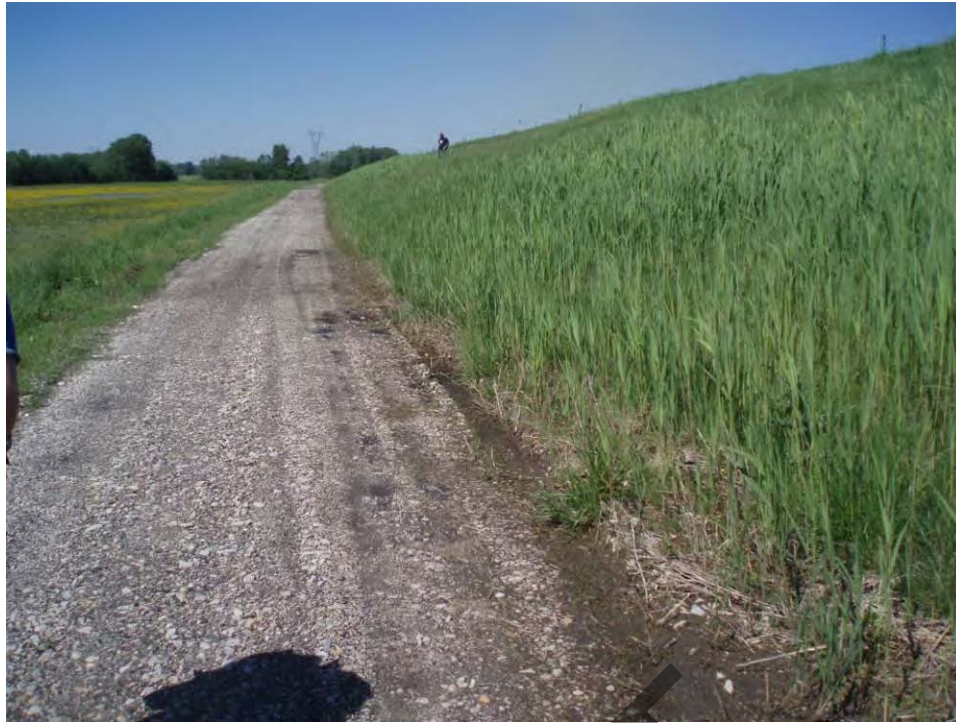
79. Pond B – West embankment bench, looking north at possible seep. Note area is soft and saturated.

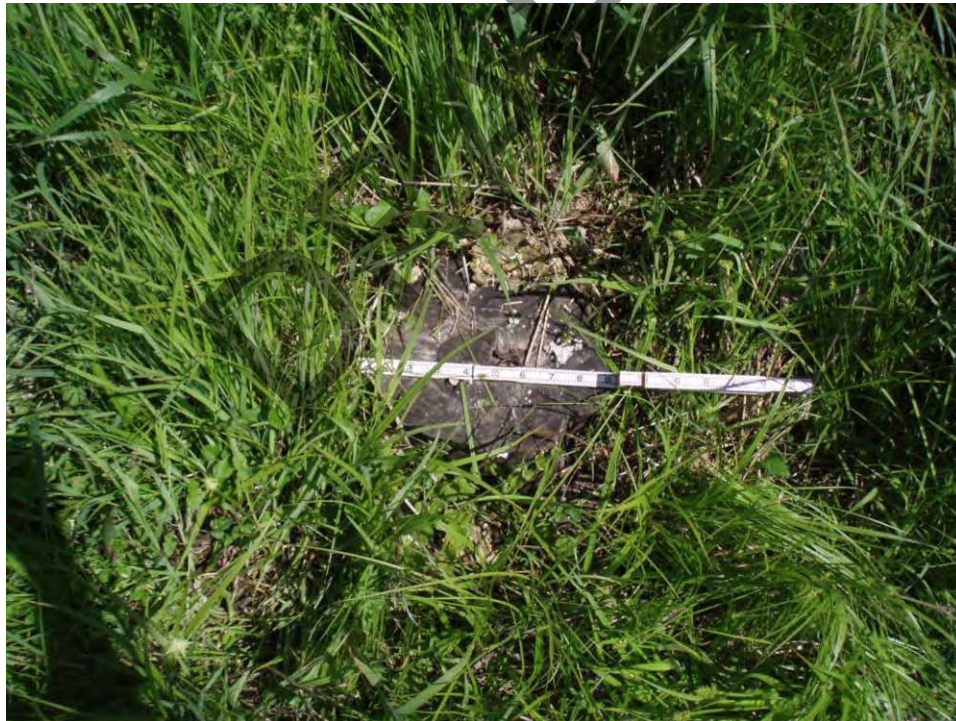
80. Pond B – West embankment lower exterior slope, looking at 0.9-foot-diameter tree stump at toe.

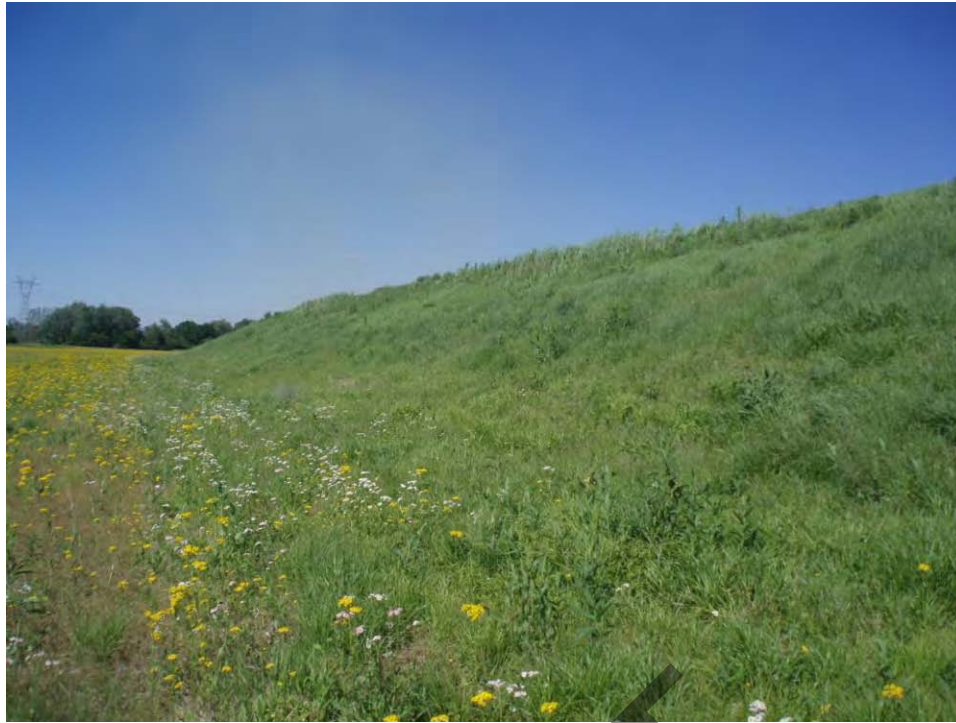
81. Pond B – West embankment lower exterior slope, looking north.

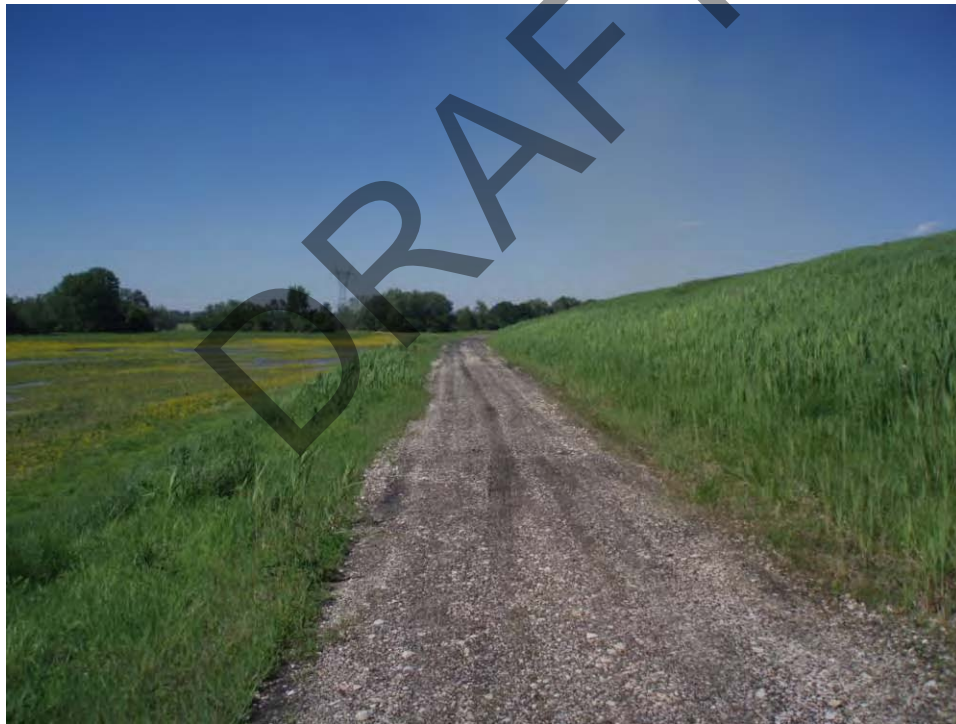
82. Pond B – West embankment bench, looking north.

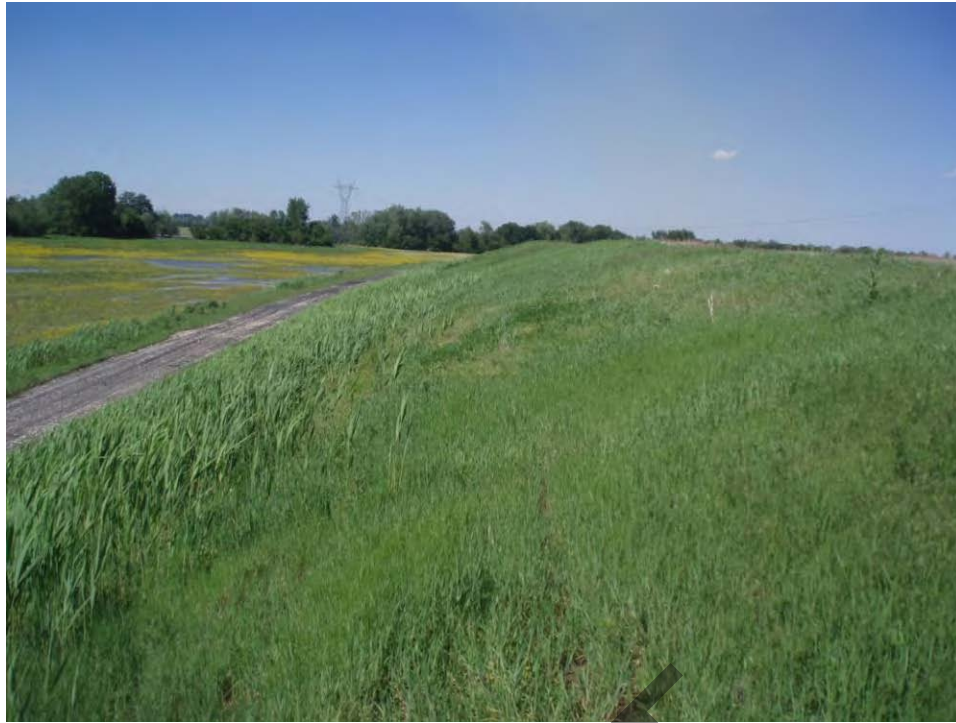
83. Pond B – West embankment upper exterior slope, looking north.

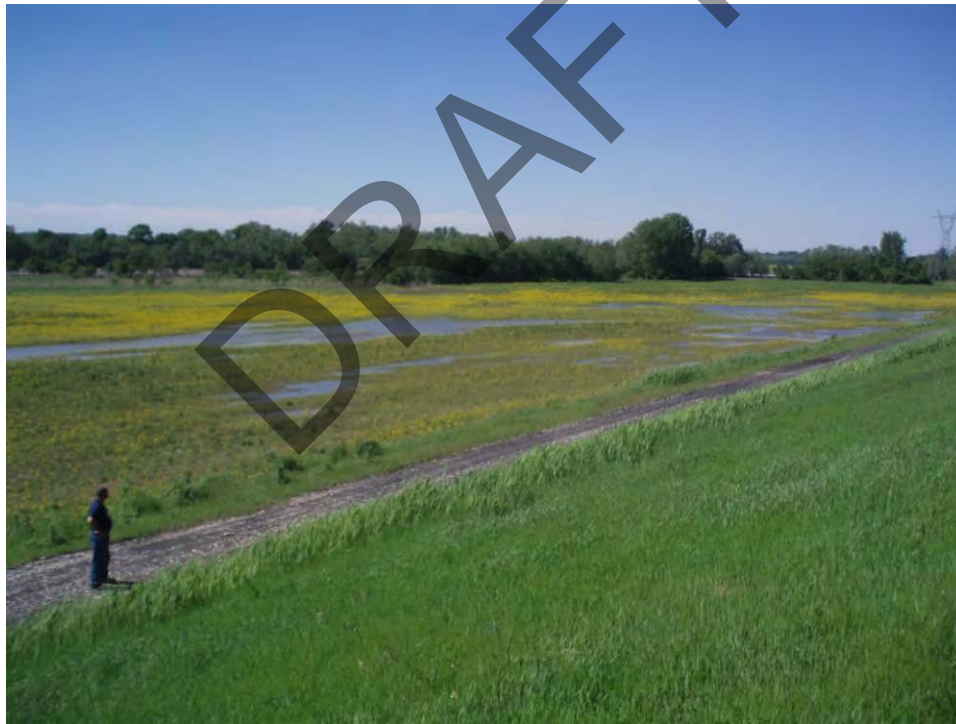
84. Overview of Pond B – West embankment, downstream area, looking northwest. Note field area is flooded from recent storm events.

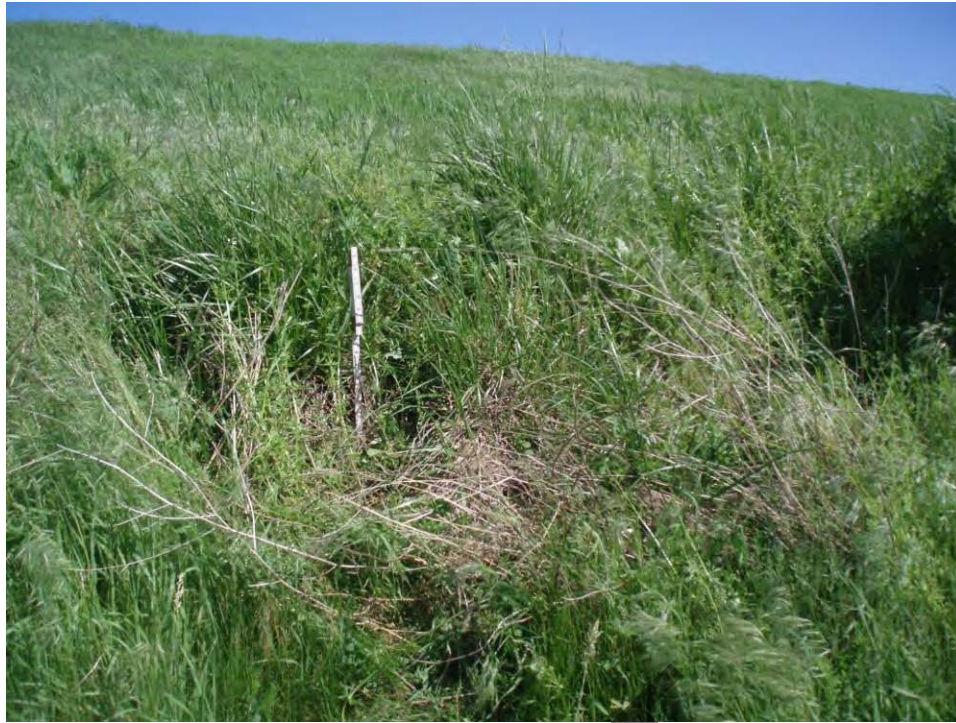
85. Pond B – West embankment lower exterior slope, looking at over-steep area and surficial erosion at bench.

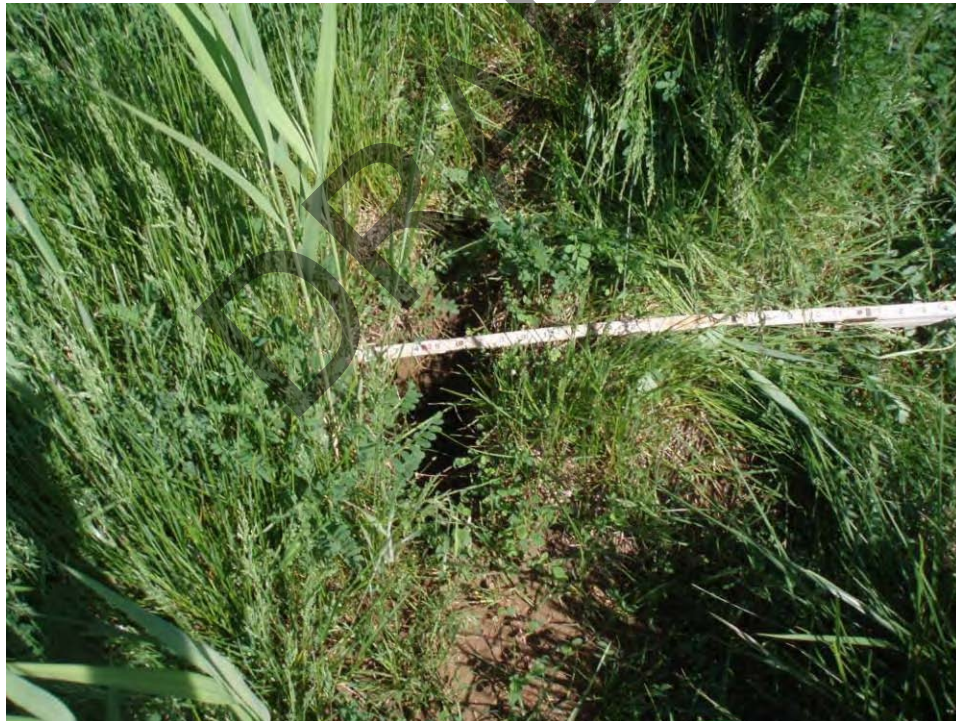
86. Pond B – West embankment upper exterior slope, looking at an 8-inch-diameter rodent hole.

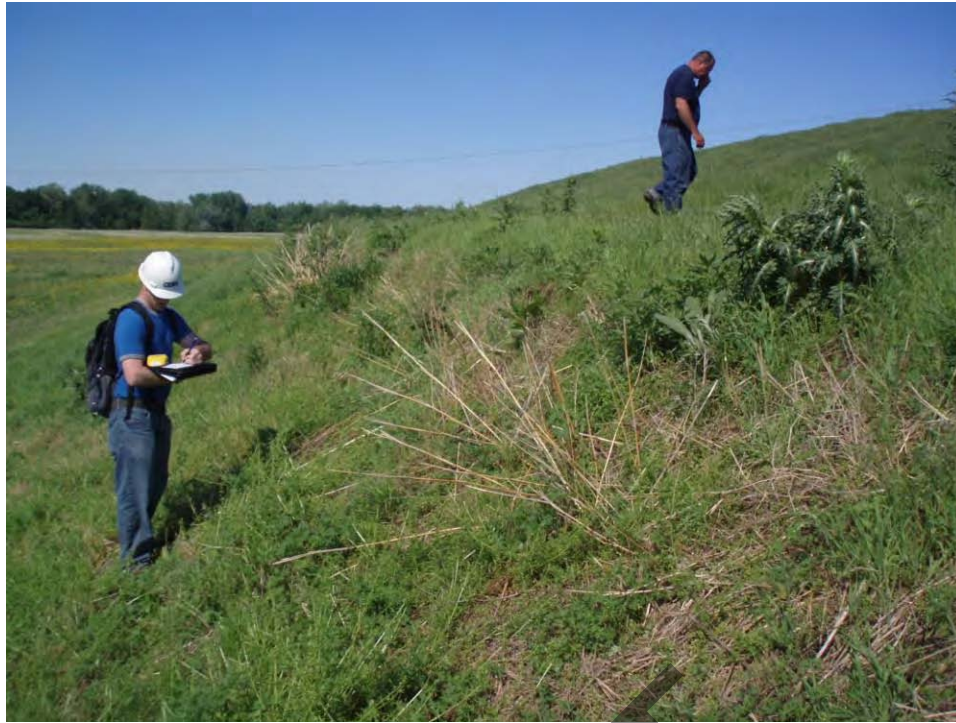
87. Pond B – West embankment lower exterior slope, looking north at over-steep slope and tractor ruts near bench.

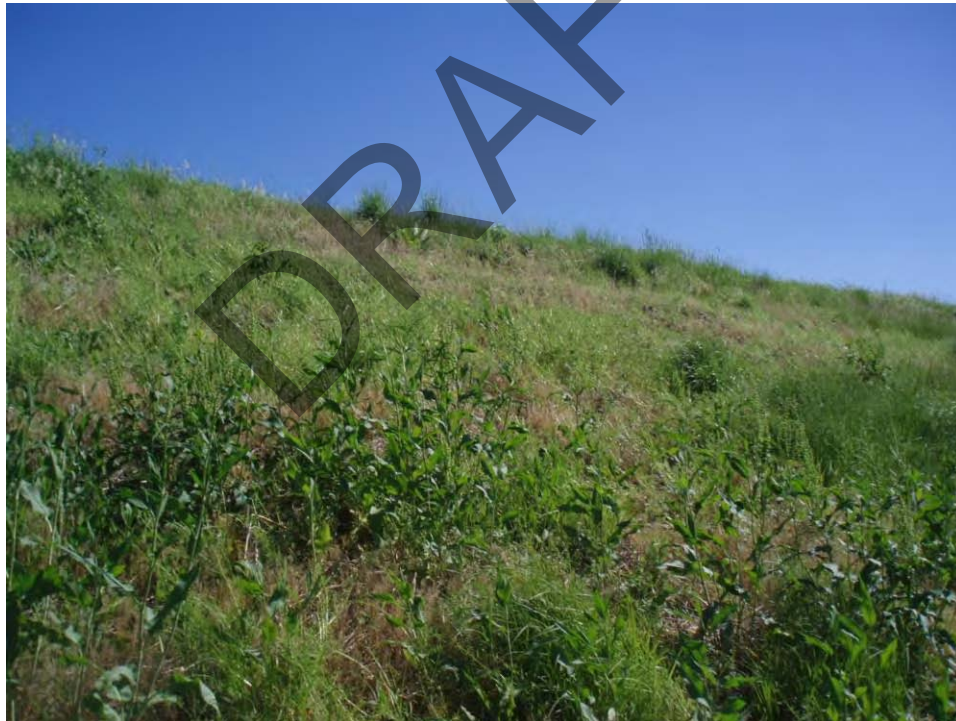
88. Pond B – West embankment lower exterior slope, looking southwest.

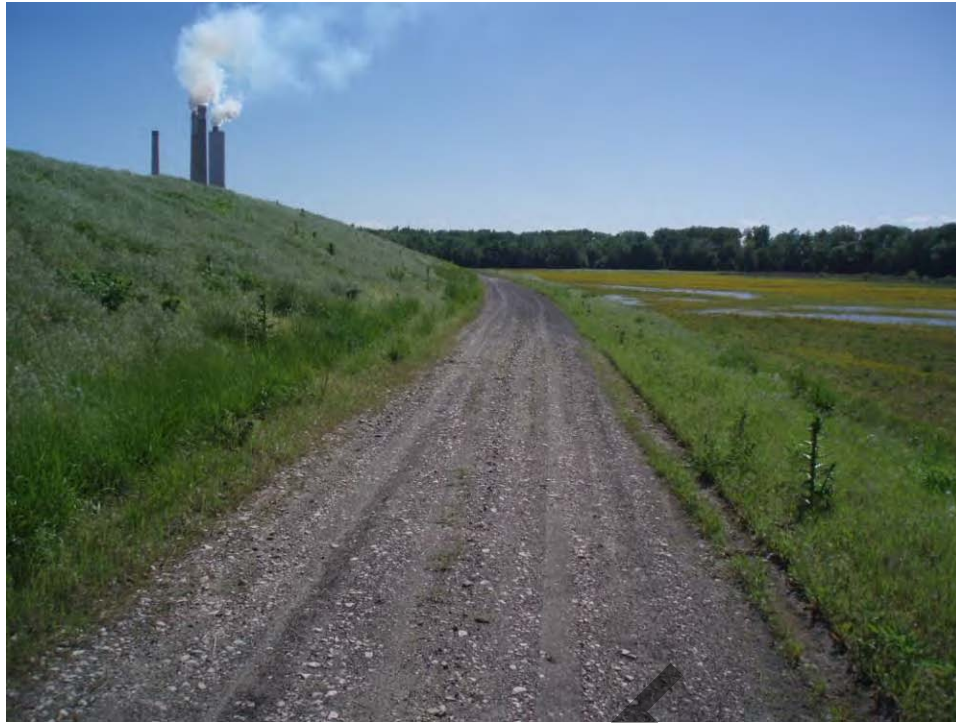
89. Pond B – West embankment bench, looking southwest.

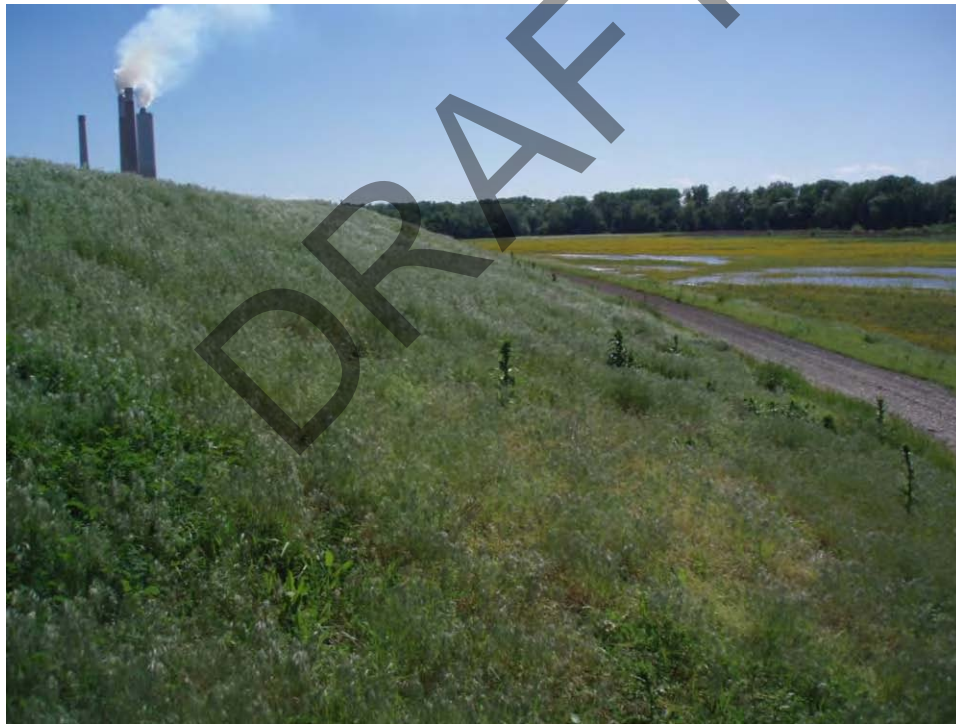
90. Pond B – West embankment upper exterior slope, looking southwest.

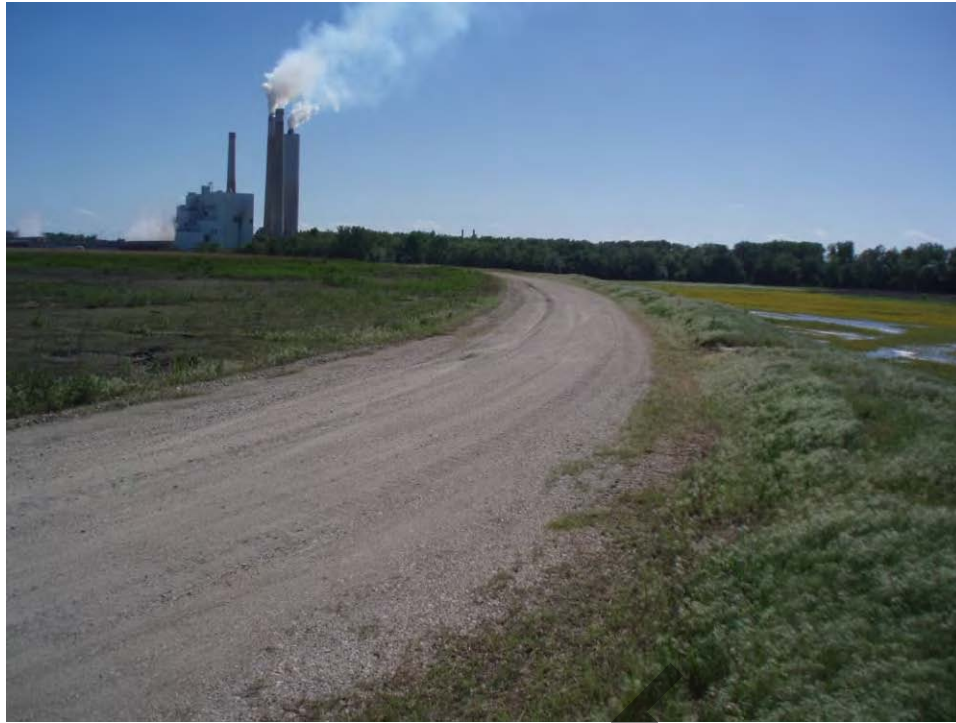
91. Pond B – West embankment crest, looking southwest.

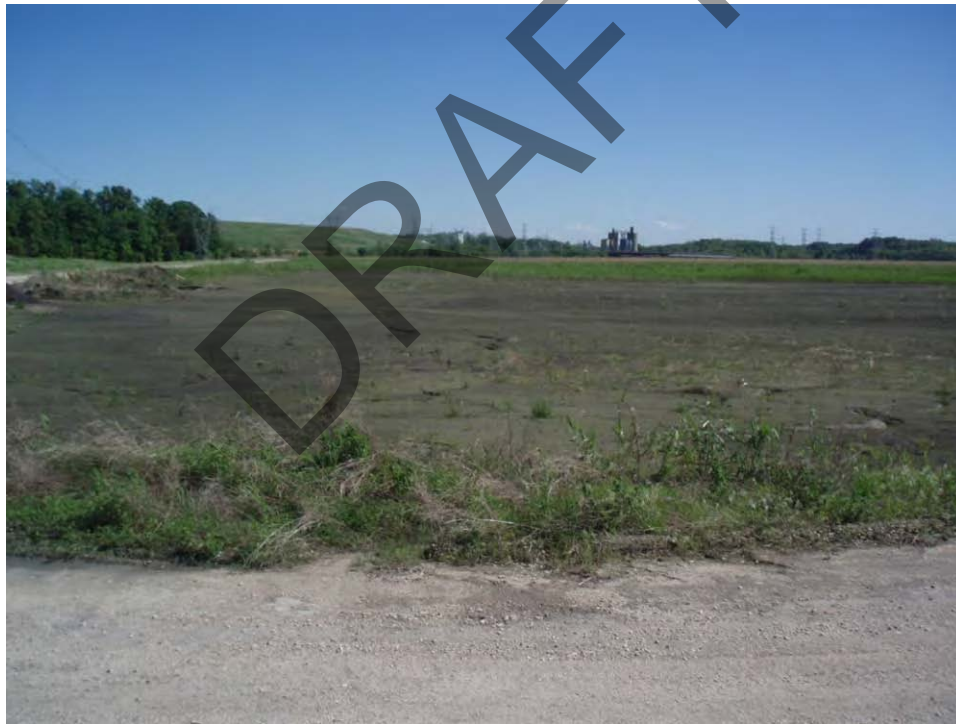
92. Overview of Pond B from northwest corner, looking southeast.

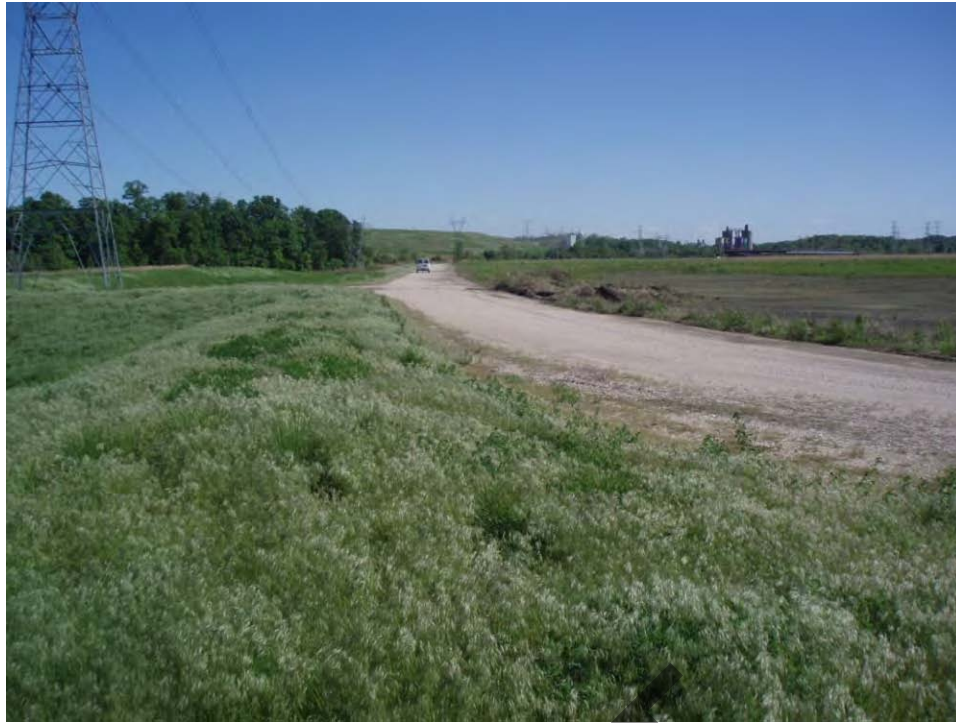
93. Pond B - North embankment crest, looking southeast.

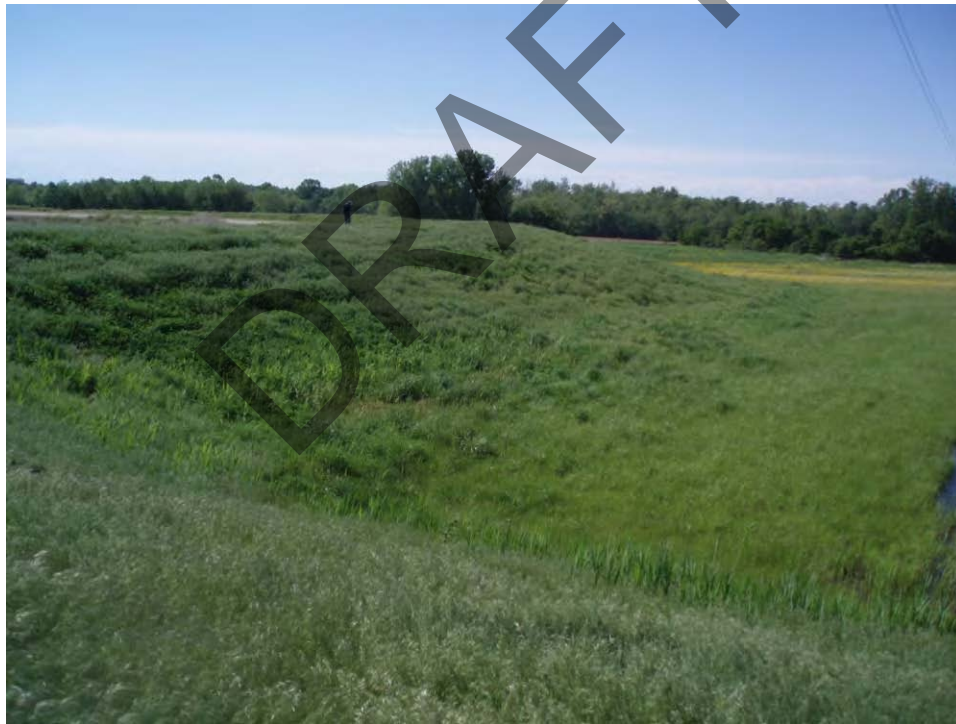
94. Pond B - North embankment exterior slope, looking northwest.

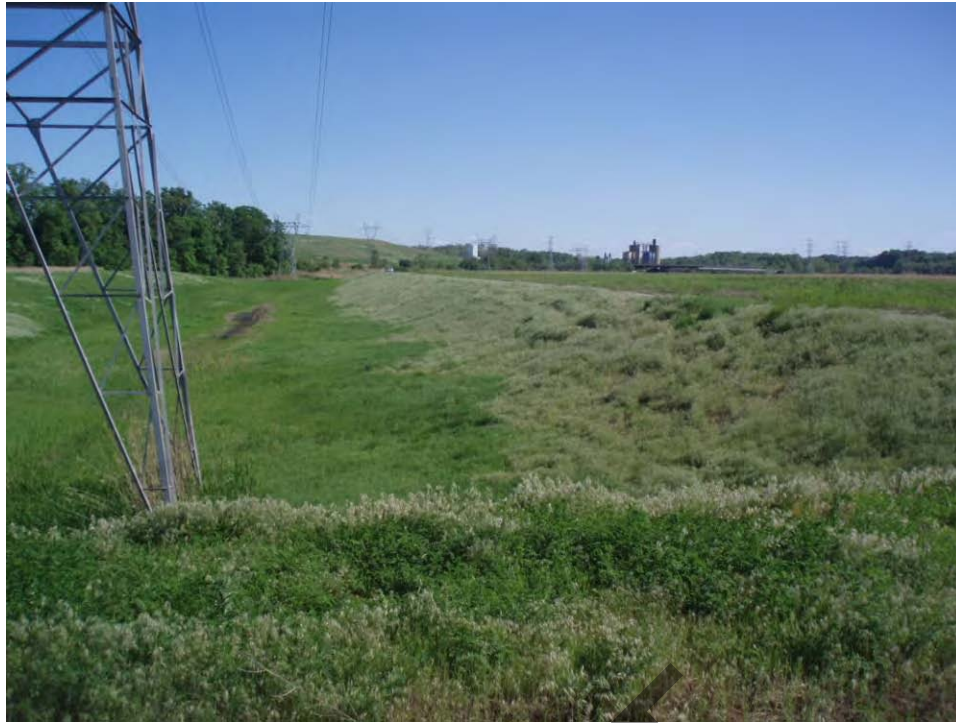
95. Pond B – North embankment exterior slope, looking southeast.

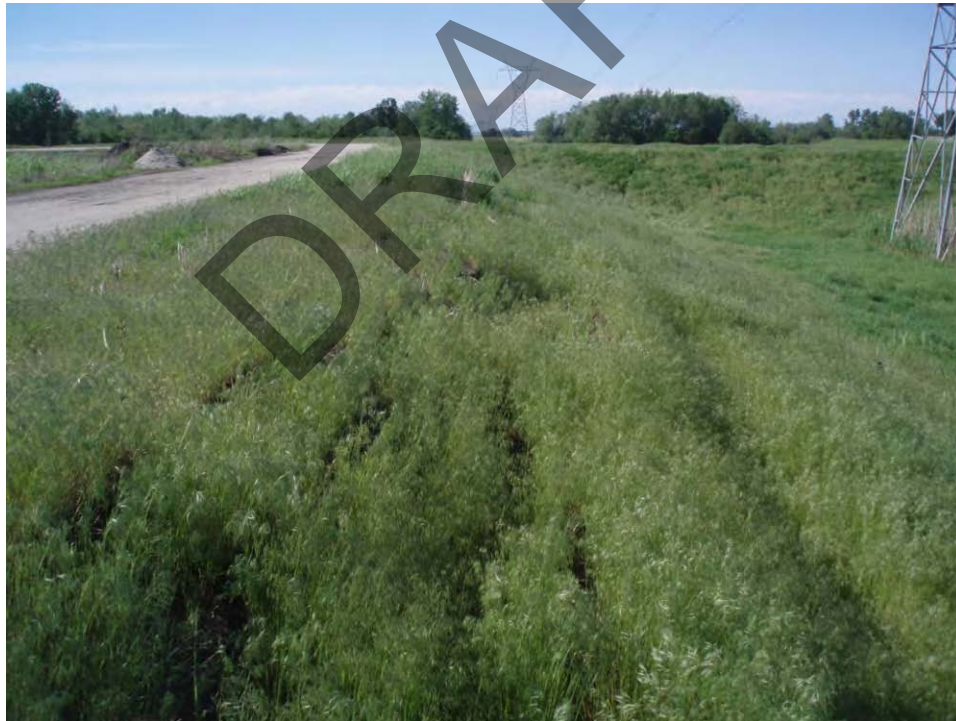
96. Pond B – North embankment exterior slope looking northwest at tractor ruts, bare spots, very soft stabilized FGD.

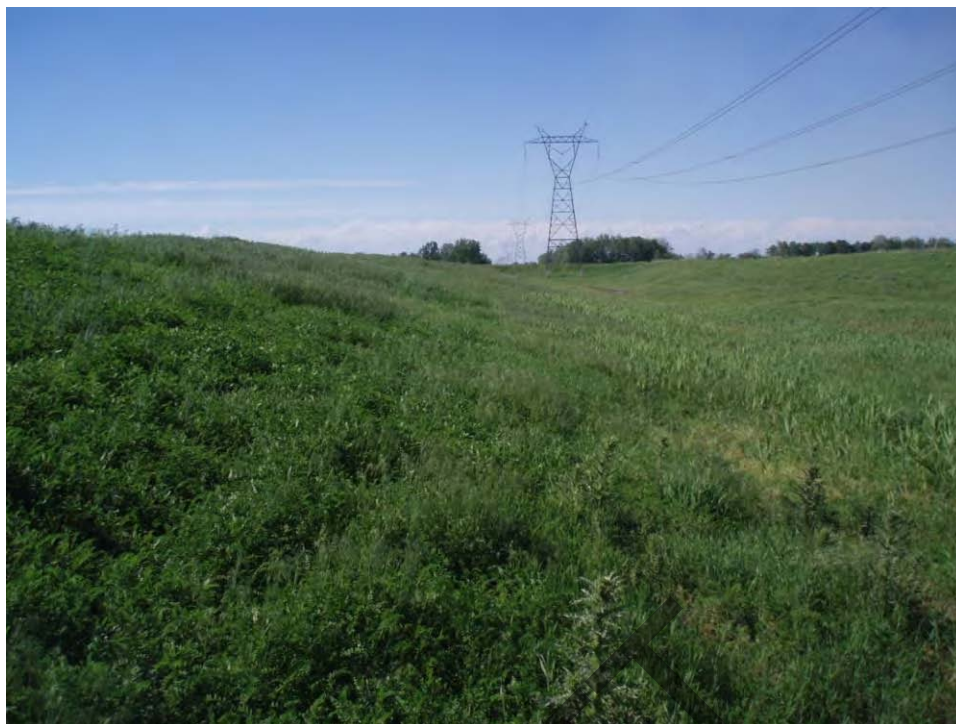
97. Pond B – North embankment exterior slope, looking northwest.

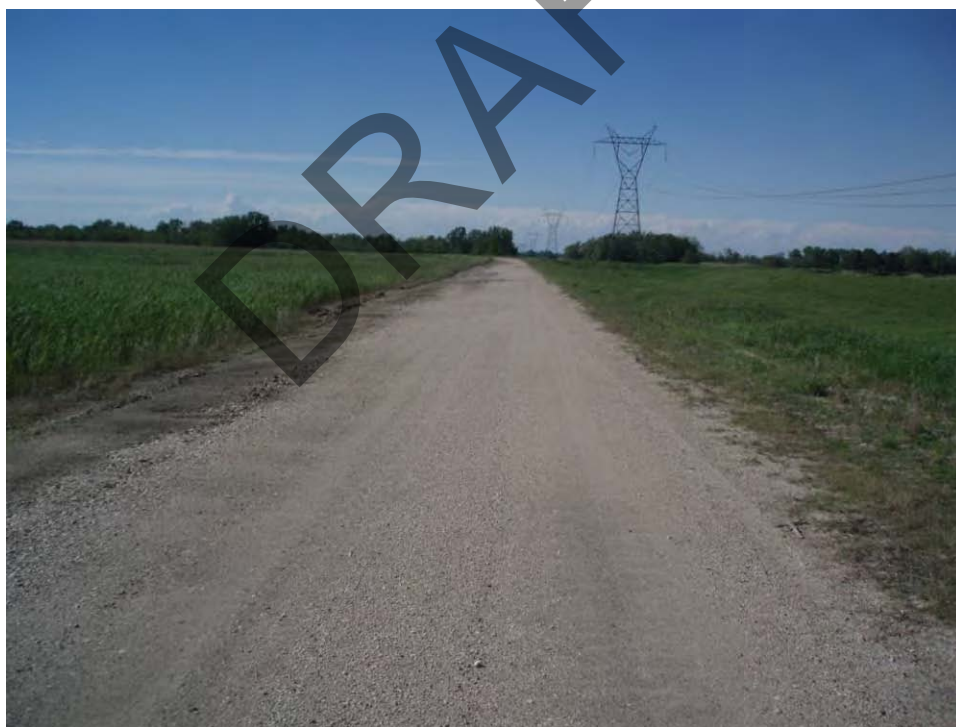
98. Pond B – North embankment crest, looking northwest.

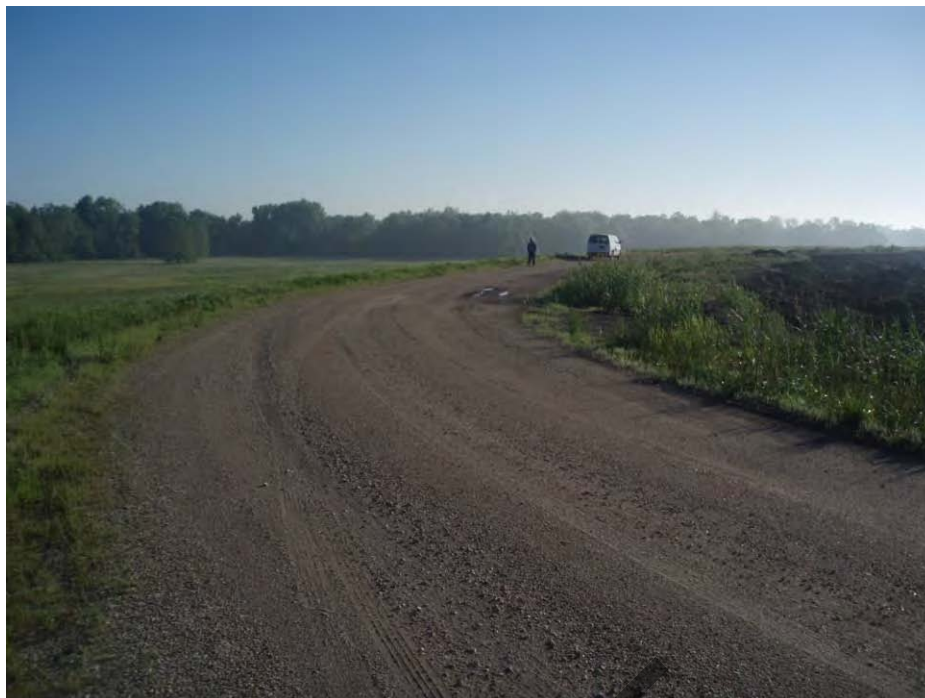
99. Pond C – West embankment crest, looking northeast.

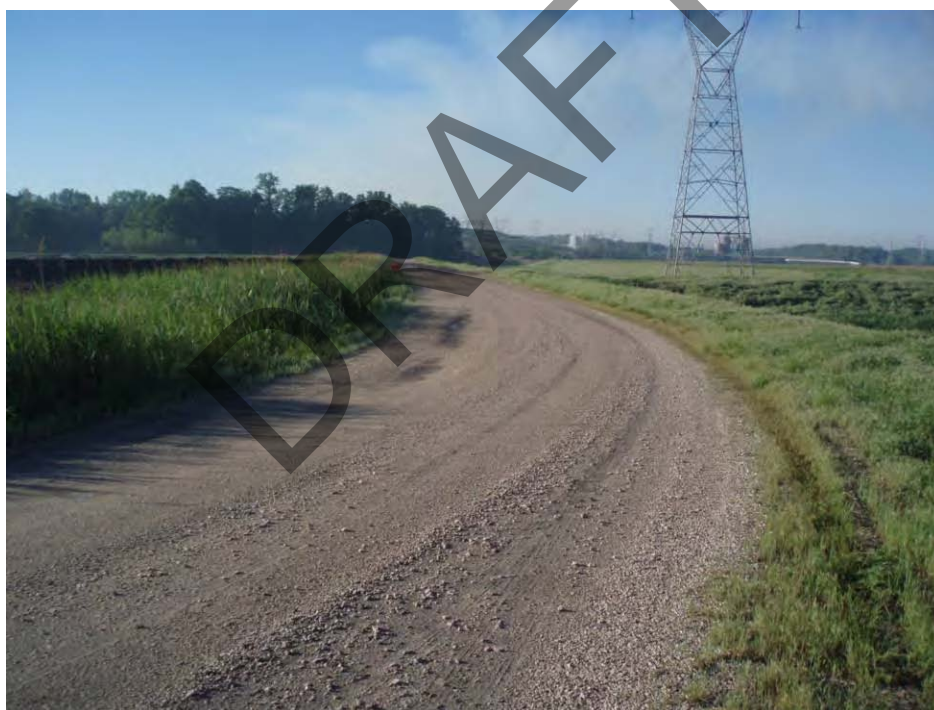
100. Pond C – South embankment crest, looking southeast.

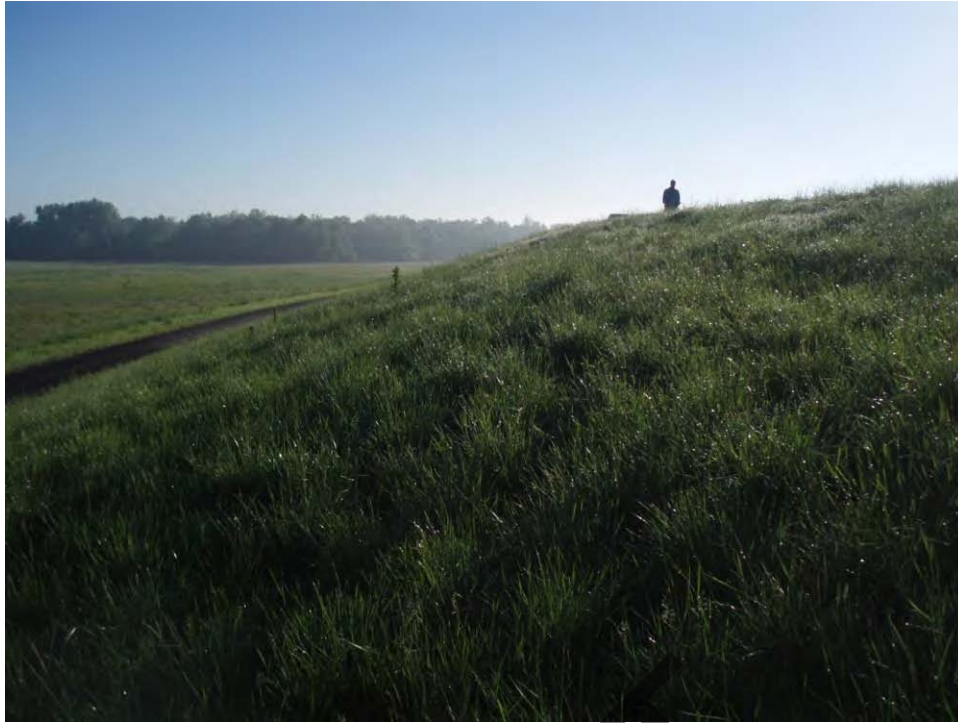
101. Pond C – West embankment upper exterior slope, looking northeast.

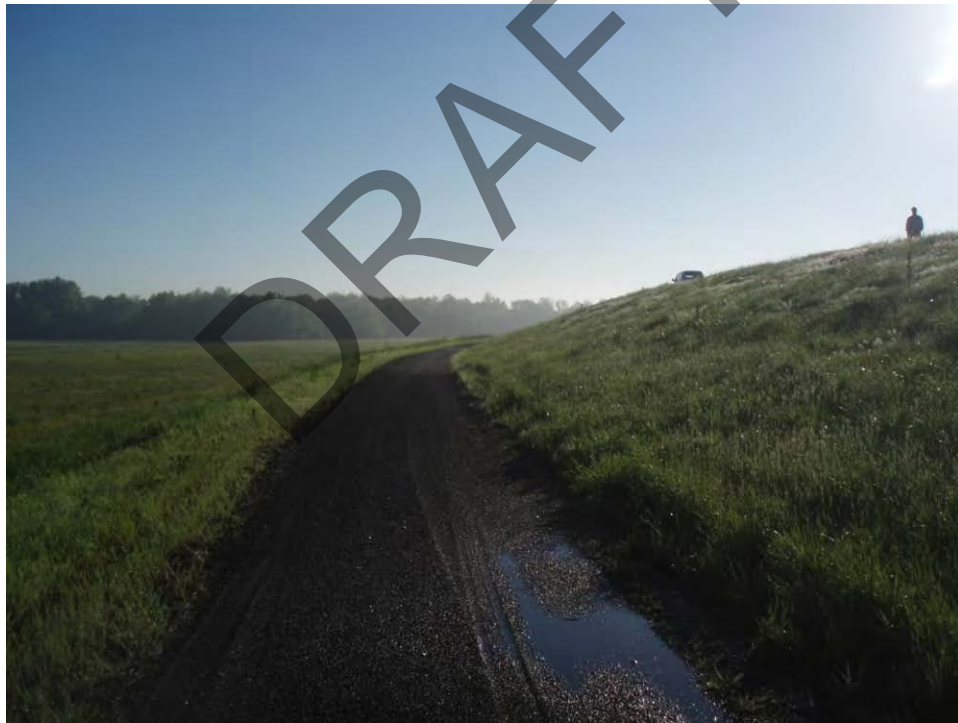
102. Pond C – West embankment bench, looking northeast.

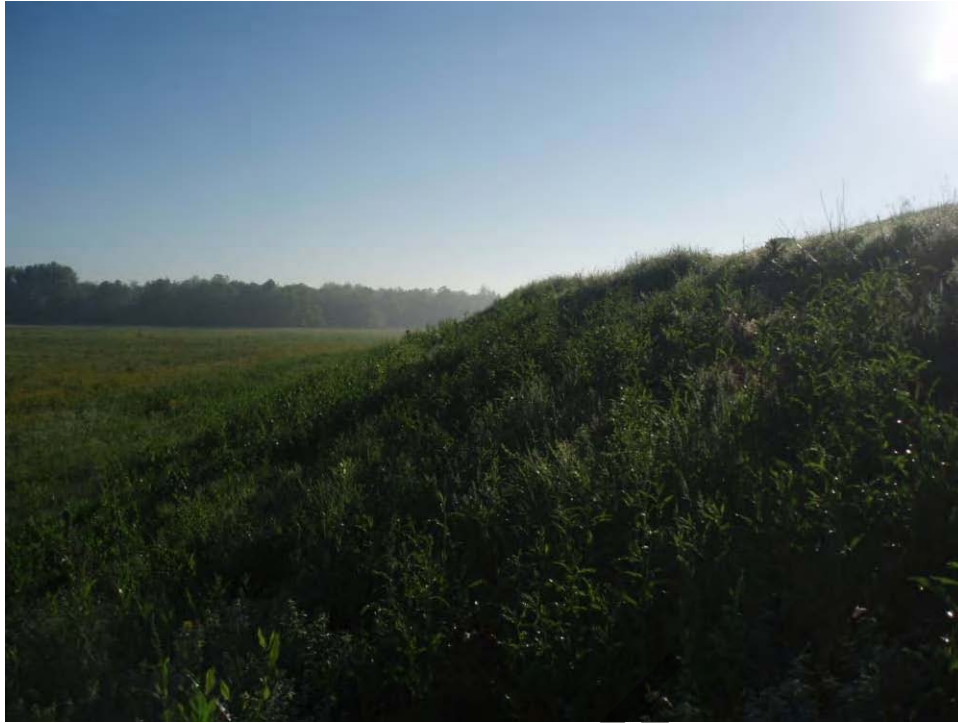
103. Pond C - West embankment lower exterior slope, looking northeast.

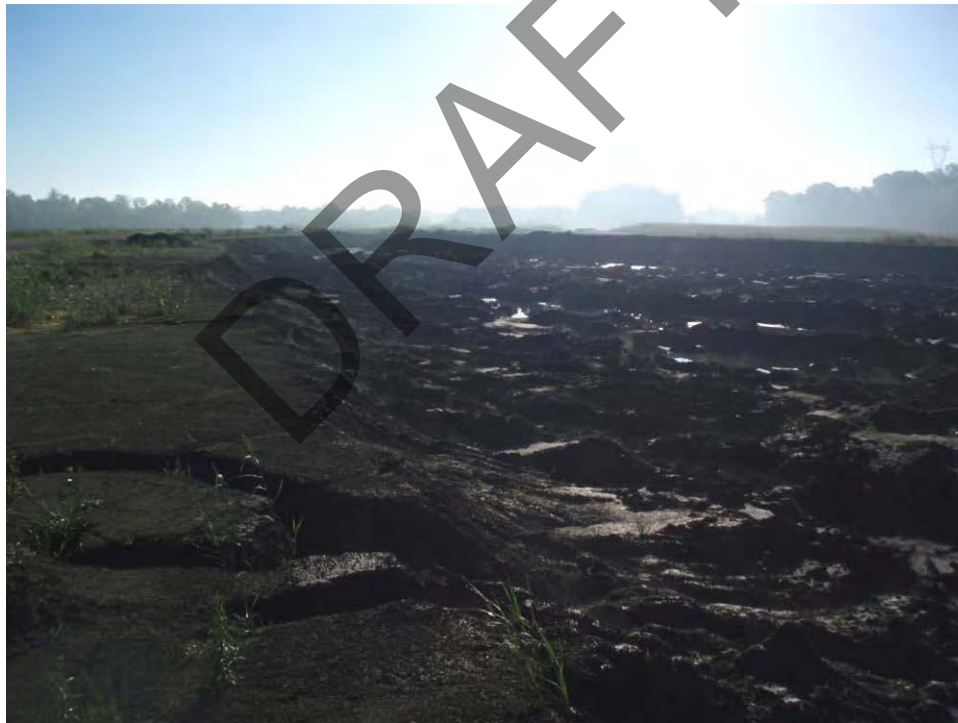
104. Overview of Pond C from northeast corner, looking east.

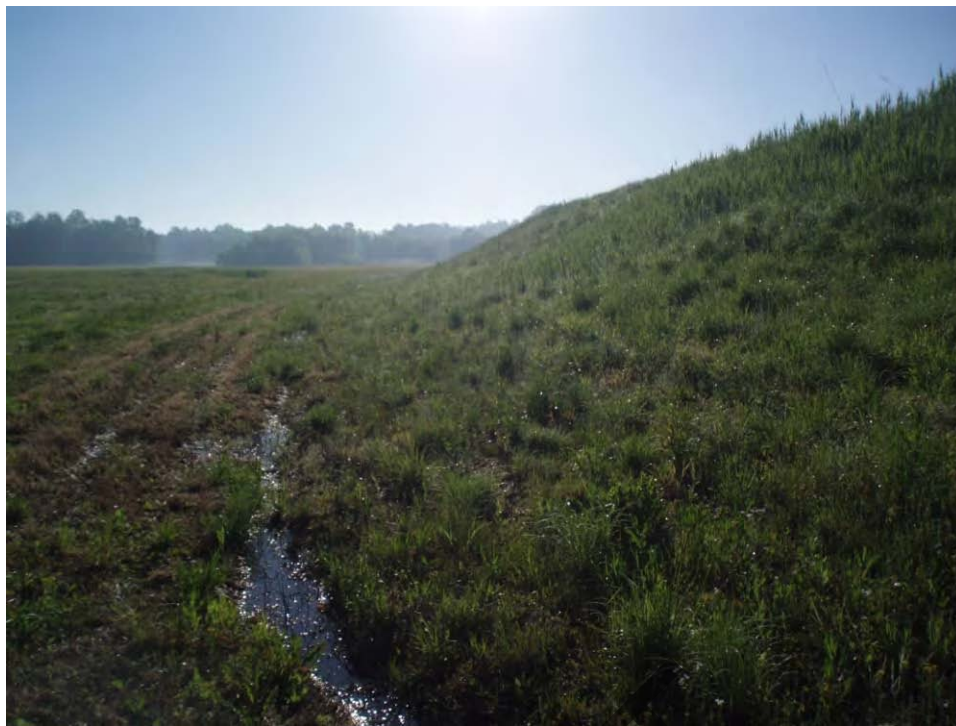
105. Pond C - West embankment lower exterior slope, looking northeast.

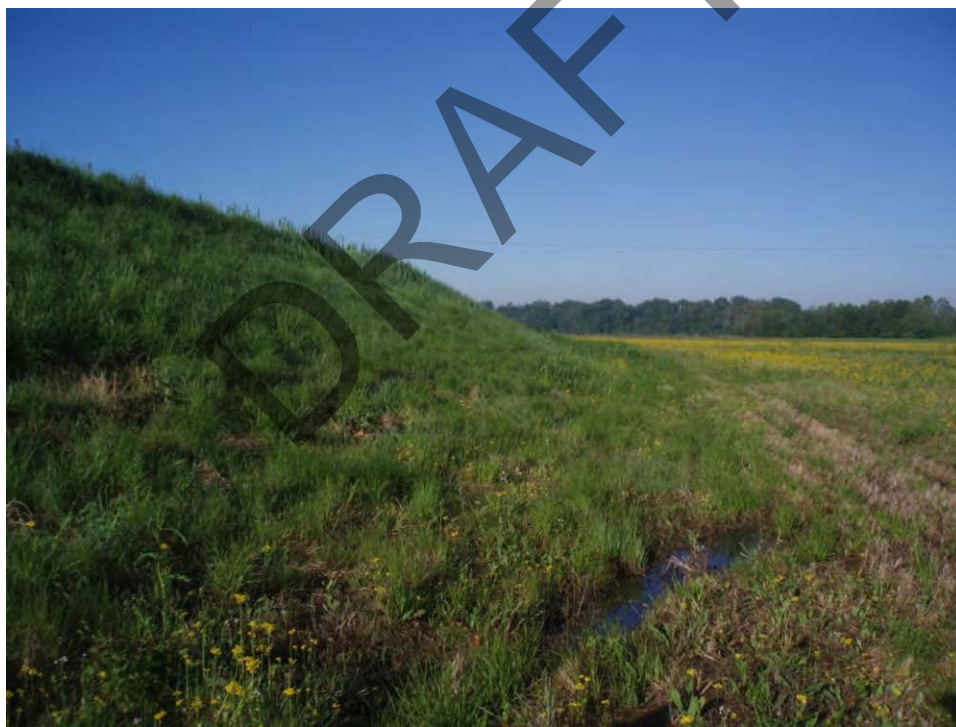
106. Pond C - West Embankment lower exterior slope, looking southwest.
